**NASA CR-2614**

**EVALUATION OF DISPERSION STRENGTHENED  
NICKEL-BASE ALLOY HEAT SHIELDS FOR  
SPACE SHUTTLE APPLICATION**

**MCDONNELL DOUGLAS ASTRONAUTICS COMPANY**

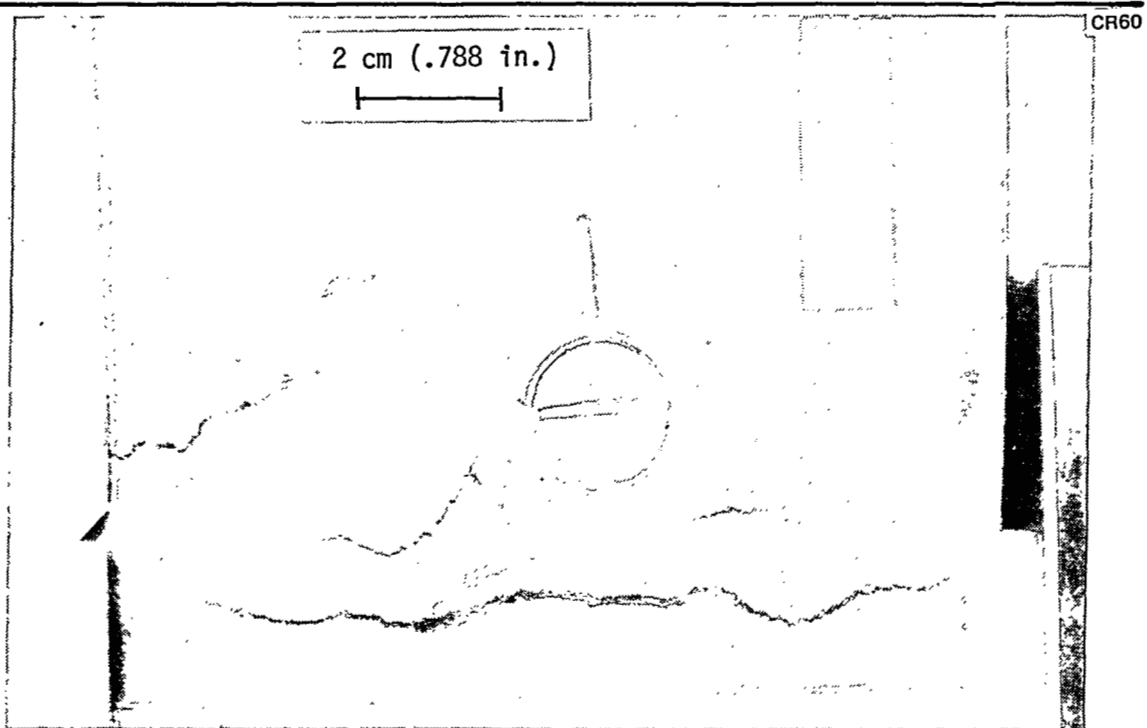
Figure 7-20. Damage in Panel No. 6 After Tenth Mission Test Cycle (Area 3)

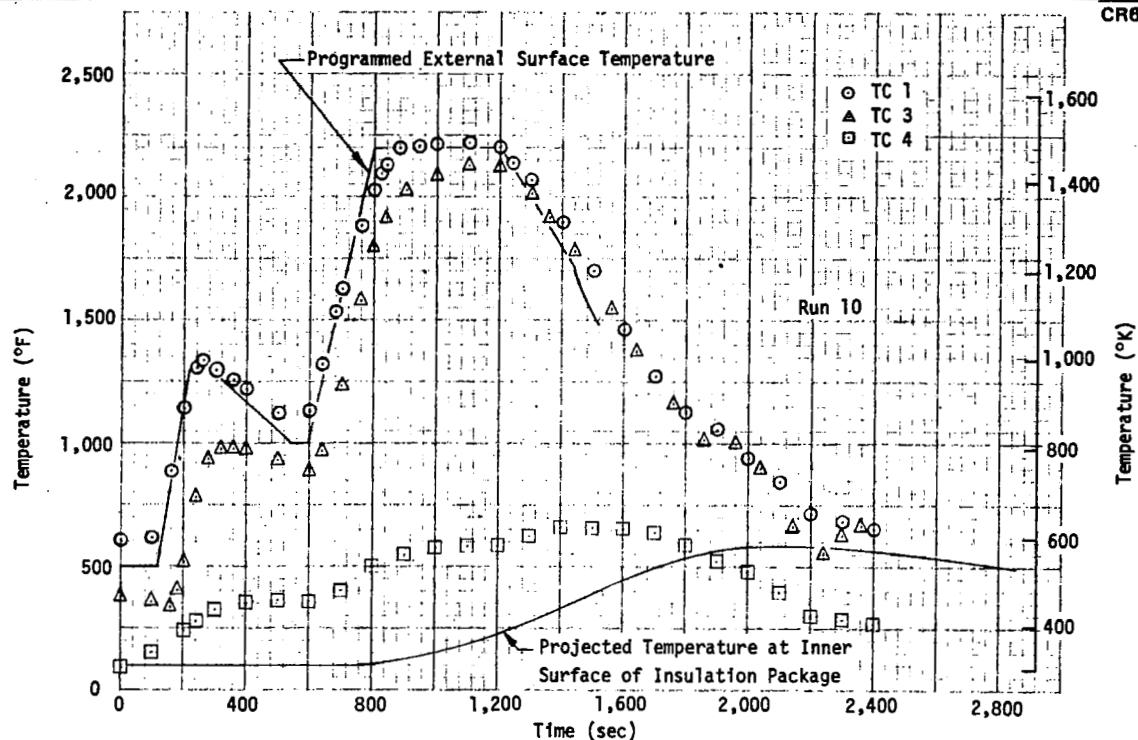
Figure 7-21. Temperature Time-Histories, Thermocouples 1, 3, 4

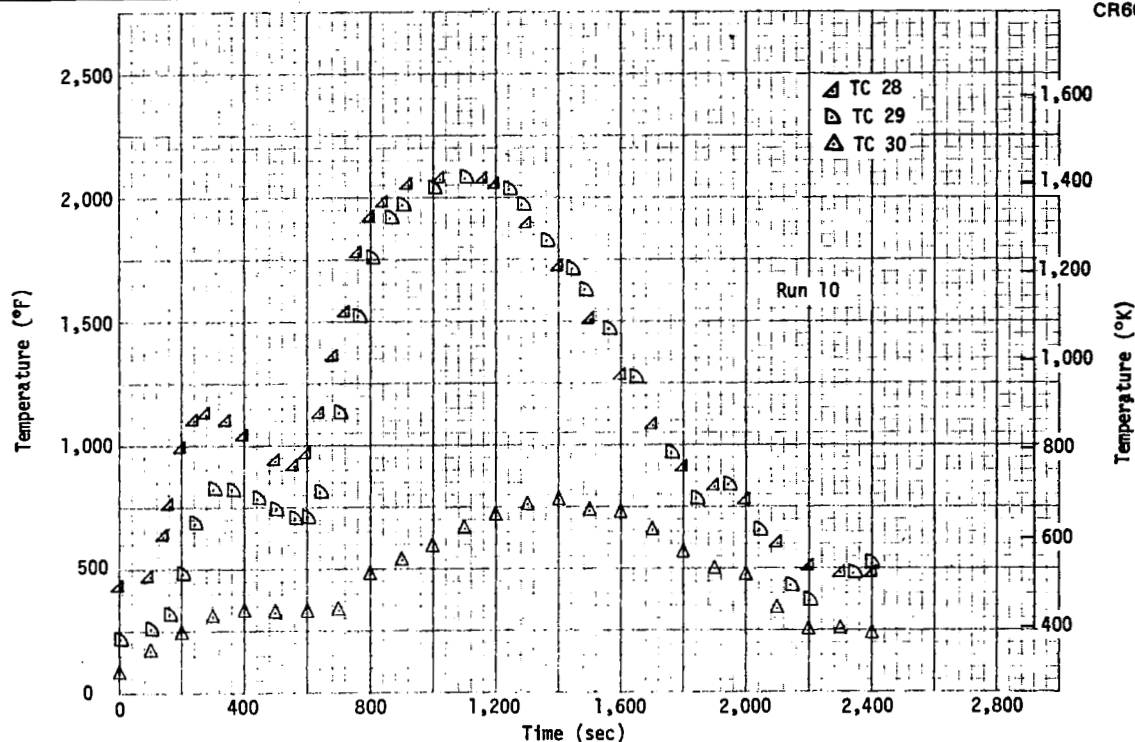
Figure 7-22. Temperature Time-Histories, Thermocouples 28, 29, 30

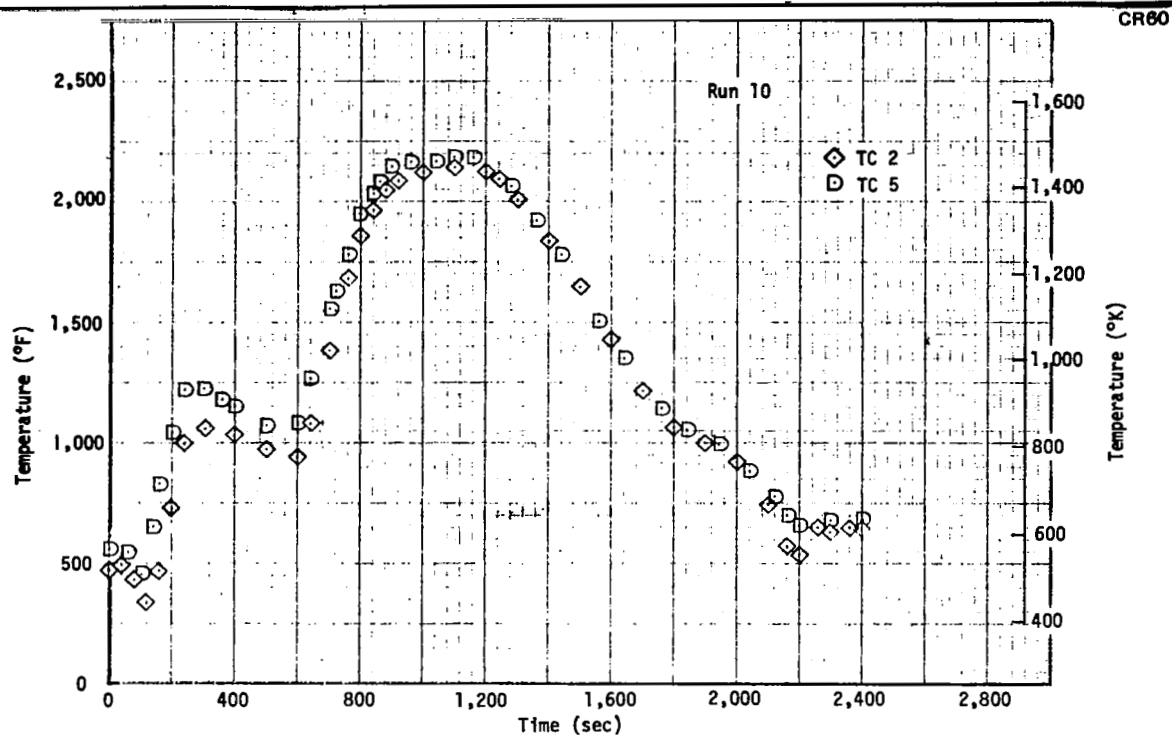
Figure 7-23. Temperature Time-Histories, Thermocouples 2, 5

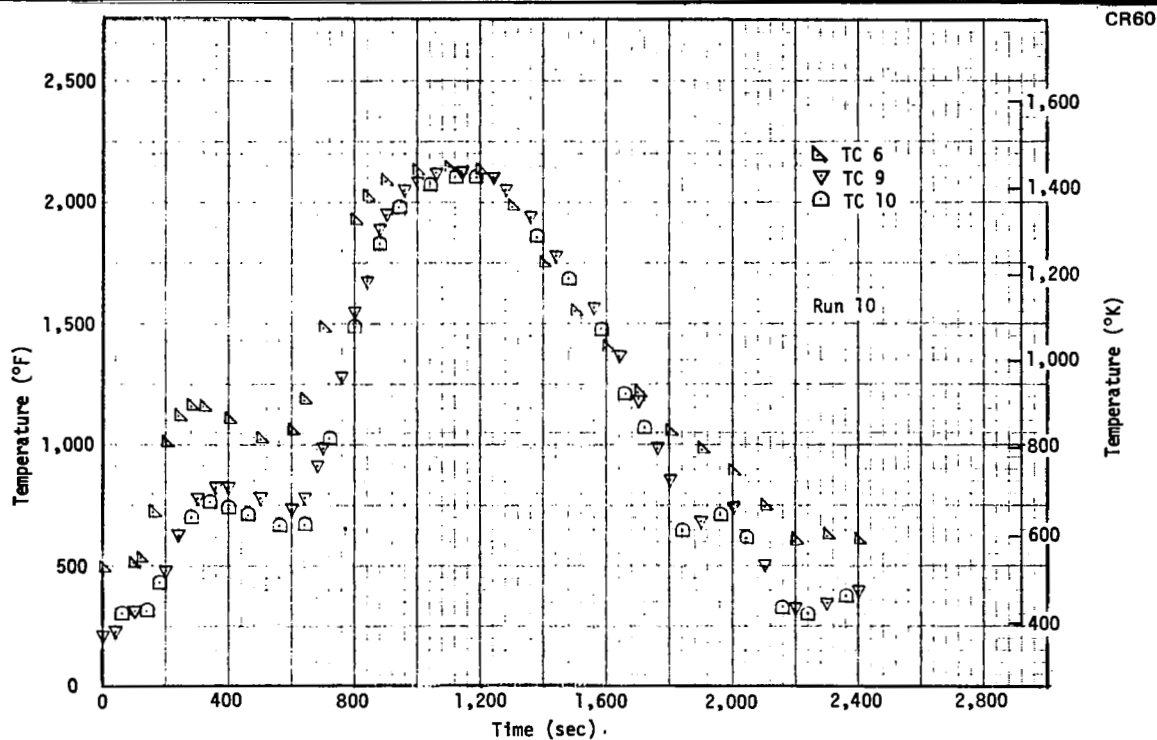
Figure 7-24. Temperature Time-Histories, Thermocouples 6, 9, 10

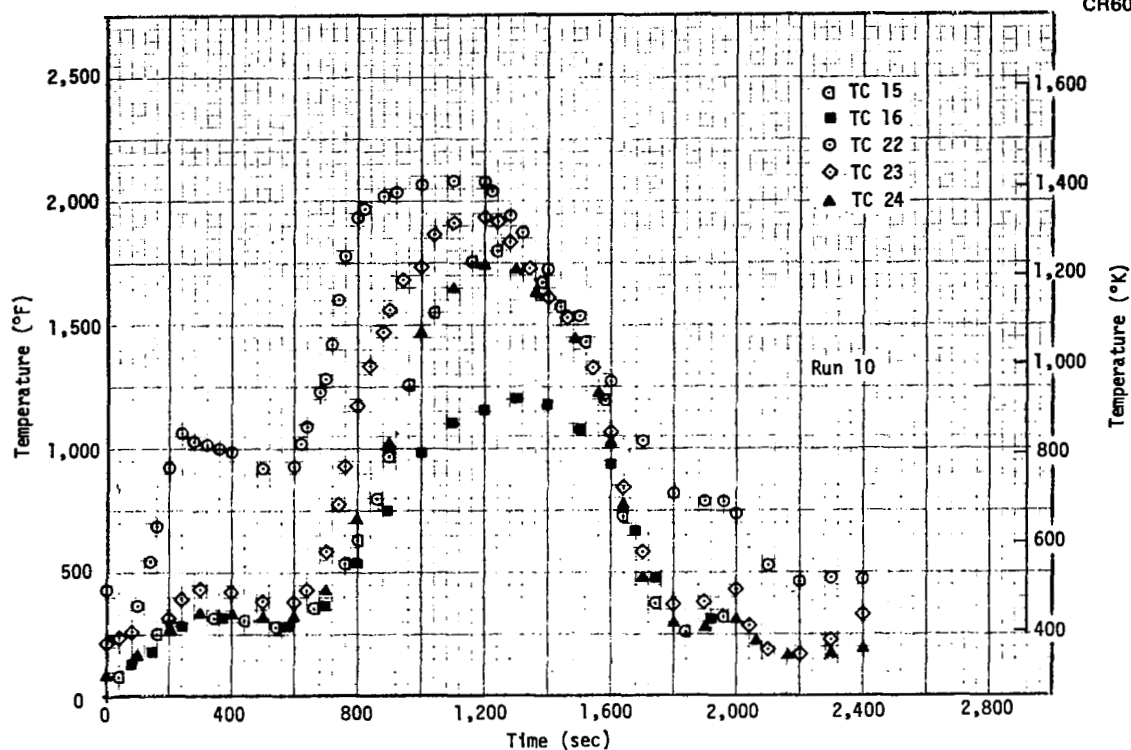
Figure 7-25. Temperature Time-Histories, Thermocouples 15, 16, 22, 23, 24

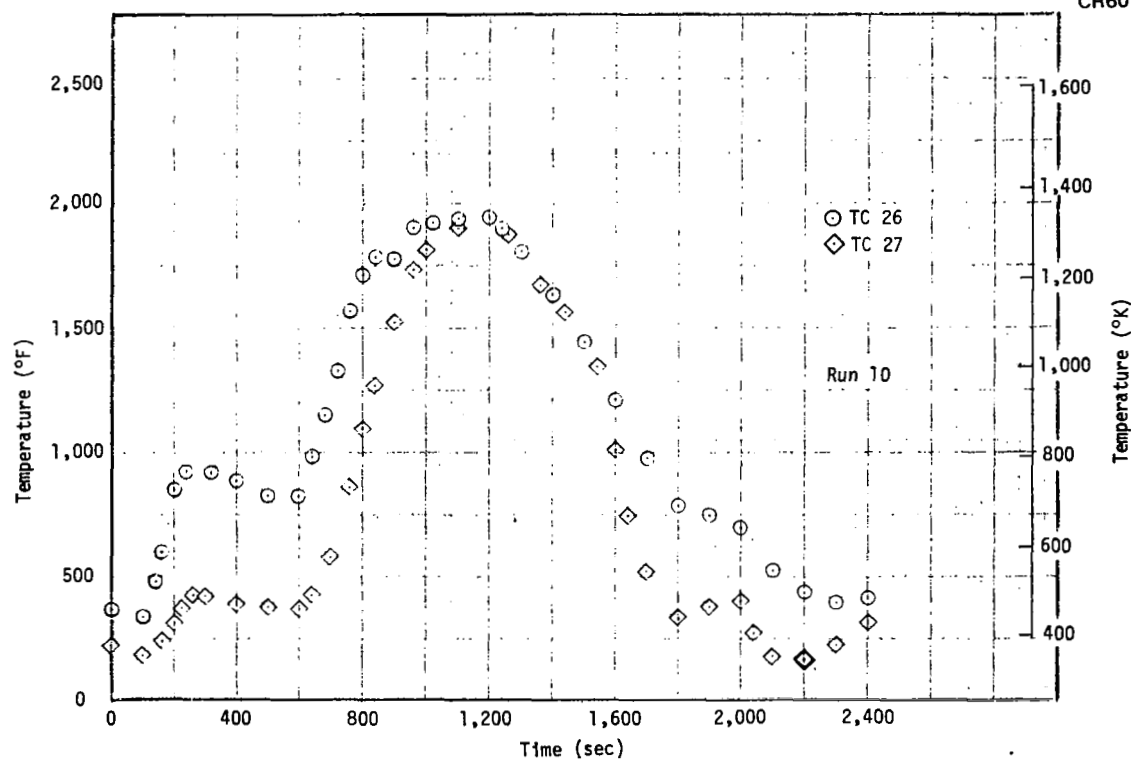
Figure 7-26. Temperature Time-Histories, Thermocouples 26, 27

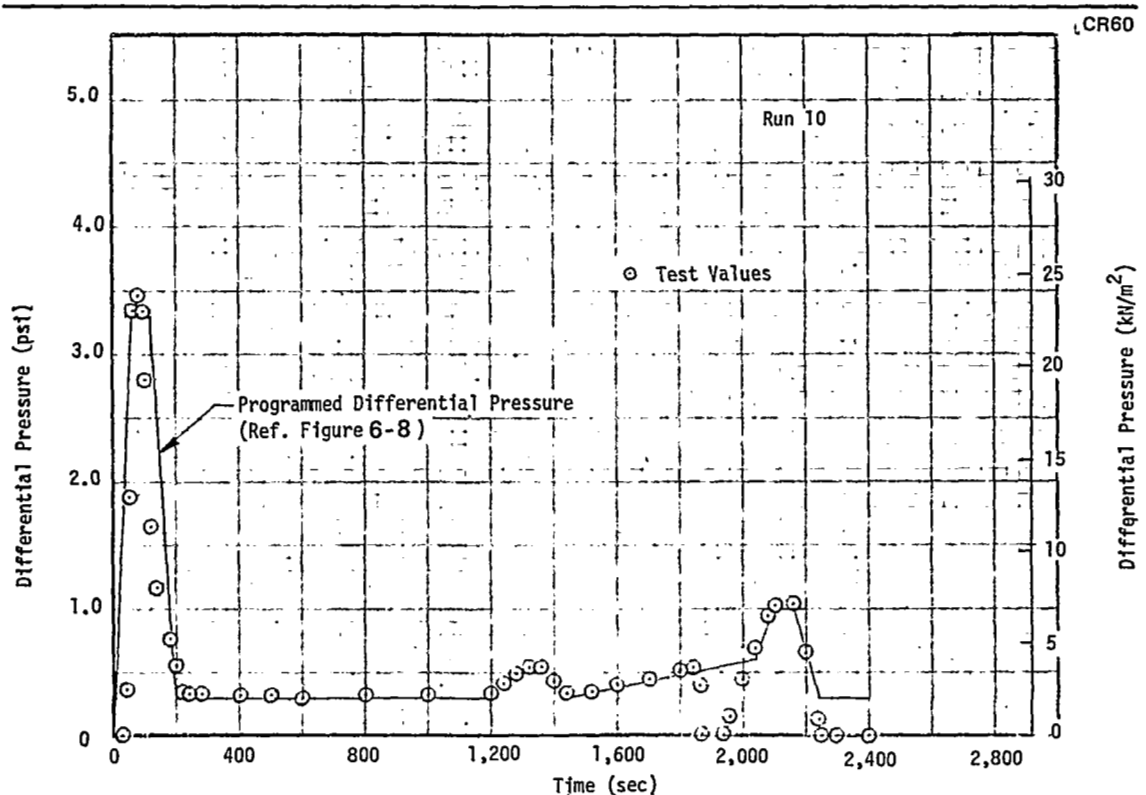
Figure 7-27. Differential Pressure Time-History

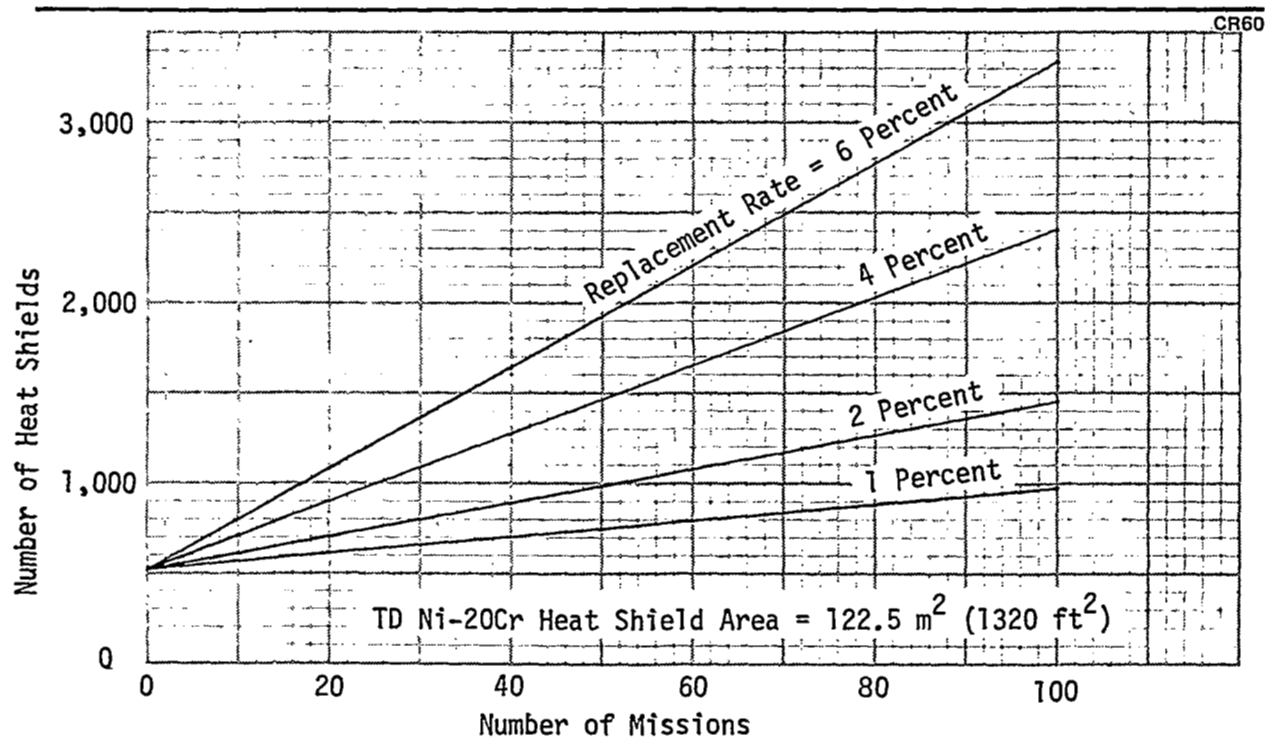
Figure 7-28. TD Ni-20Cr Heat Shield Requirements Per Vehicle

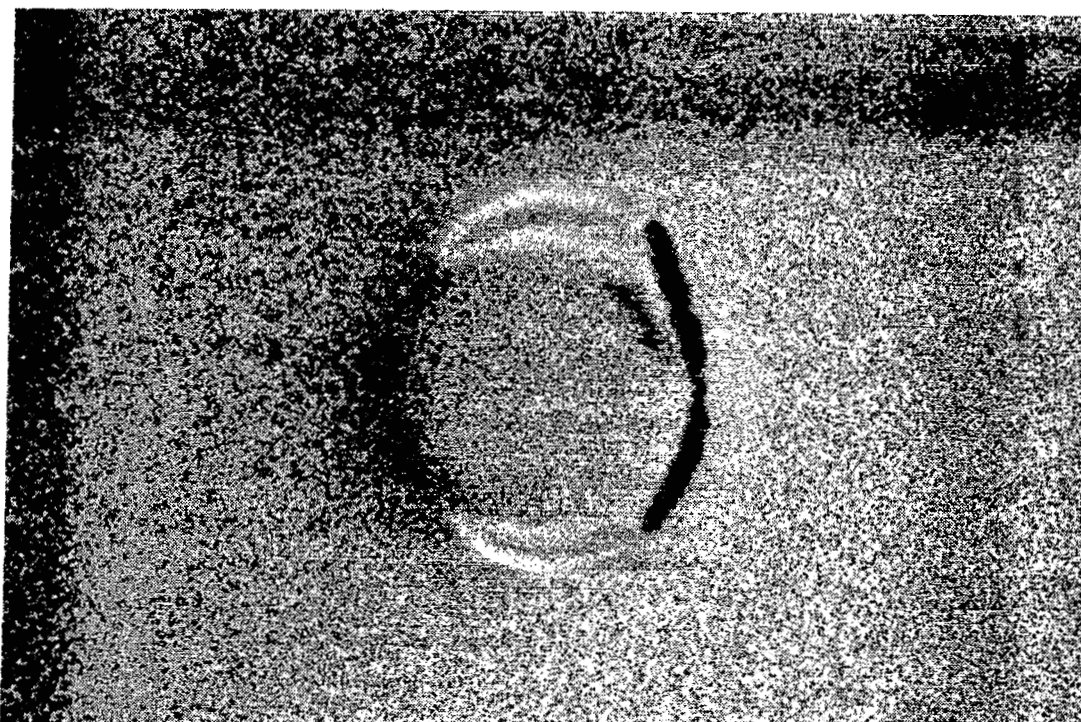
b. Closeup of Crack Shown by Dye-Penetrant
